Sun Fire X4100 M2/X4200 M2 Servers

Product Notes

Part No. 819-5038-23
October 2010, Revision A

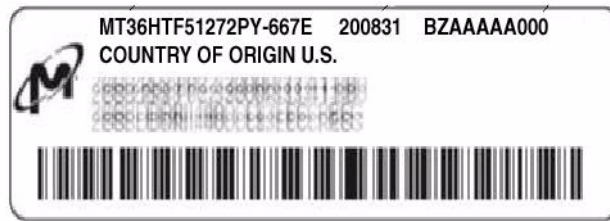
Some 4-GB DIMMs supplied for use with dual-core systems can have single-bit or multiple bit errors after systems are upgraded to quad-core. Symptoms include sudden crashes and failure to boot. Not all existing 4GB DIMMs are affected.

If you are planning to upgrade your system to use quad-core processors, you should visually inspect any existing 4-GB DIMMs. Affected DIMMs have a a Micron label similar to the one below.

The affected DIMMs can be identified by the logo and the first two numbers on the label.

- The logo will be for a Micron product, as shown in the above illustration.
- The first number is the vendor's part number. On affected DIMMs it is MT36HTF51272PY-667E.
- The second number is the manufacturing date code. On affected DIMMs it is a value lower than 200832, indicating that the DIMM was manufactured before the 32nd week of 2008.

If the label matches the above description, it is not compatible with a quad-core processor. To obtain a replacement, contact Sun Service, and refer to FAB 244406.
