Sun Fire™ X4250 Server Product Notes

Part No. 820-4211-22
December 2009, Revision A

Sun Fire X4250 Server Product Notes

This document contains late-breaking information and issues for the Sun Fire™ X4250 server.

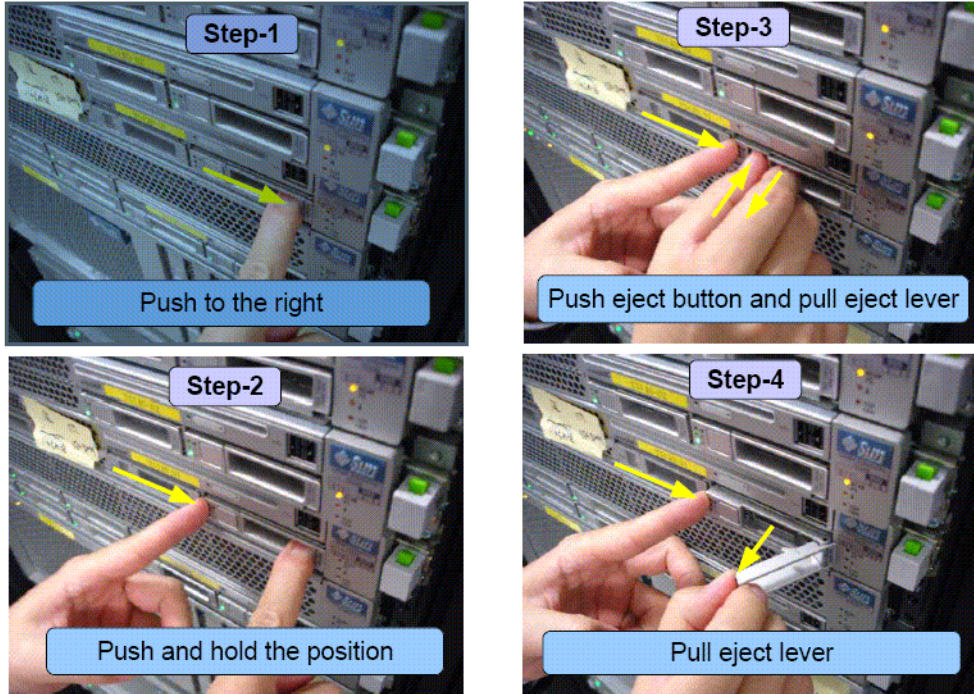
FIGURE 1 Removing Hard Drives From Right-Side Bays

Hard Drives Can Be Difficult to Remove From Right-Side Drive Bays

Hard Drives in the right-side drive bays can be difficult to remove.

Until a mechanical fix is implemented, use the following procedure to remove hard drives from right-side drive bays.

1. **Press the drive to the right. See Step 1 in the following figure.**
2. **Push in on the drive, while holding it pressed to the right. See Step 2 in the following figure.**
3. **Press the drive eject button and pull on the eject lever. See Step 3 in the following figure.**
4. **Use the eject lever to slide the drive out of the bay.**
