Sun Netra™ X4200 M2 Server Product Notes

Part No. 820-0067-13
May 2009, Revision A

Important Information About the Sun Netra X4200 M2 Server

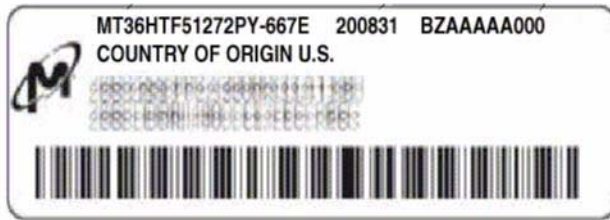
FIGURE 1 Micron DIMM Label

Some 4-Gbyte DIMMs supplied with dual-core systems can have single-bit or multiple-bit errors after systems are upgraded to quad-core. Symptoms include sudden crashes and failure to boot.

Not all existing 4-Gbyte DIMMs are affected. Affected DIMMs can be identified by Micron logo on the vendor's label and the part number and date code (see [FIGURE 1](#)).

- The vendor's part number is the first number. On affected DIMMs the part number is MT36HTF51272PY-667E.
- The manufacturing date code is the second number. On affected DIMMs the date code is a value lower than 200832, indicating that the DIMM was manufactured before the 32nd week of 2008.

If the label matches the preceding description, it is not compatible with a quad-core processor. To obtain a replacement, contact Sun Service, and refer to FAB 244406.
