Sun Fire X4800 Server Product Notes

Part No: E69641-13
September 2018

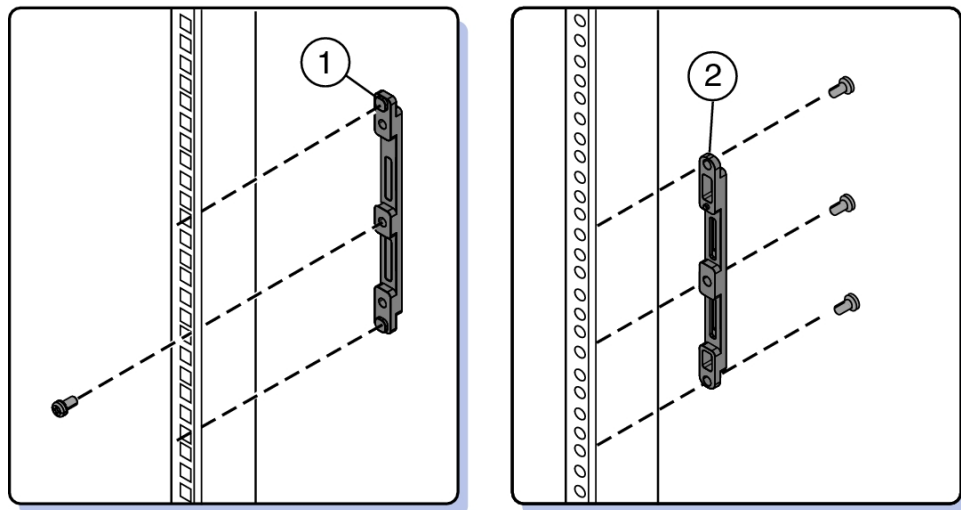
The following figure shows the front mounting brackets for both square-hole racks (1) and for threaded racks (2). In the Installation Guide and in this figure, (1) is correct and unchanged. However, in the Installation Guide, (2) is incorrect. The following figure shows (2) correctly.

- This figure is incorrect in 821–0285–10, the printed version of this document.
- They are shown correctly in 821–0285–11, the online version of this document.

Instead, the screws should be inserted from the back of the rack.
