Sun Blade™ X6275 Server Module

Product Notes

Part No. 8820-6853-19
November 2010, Revision A

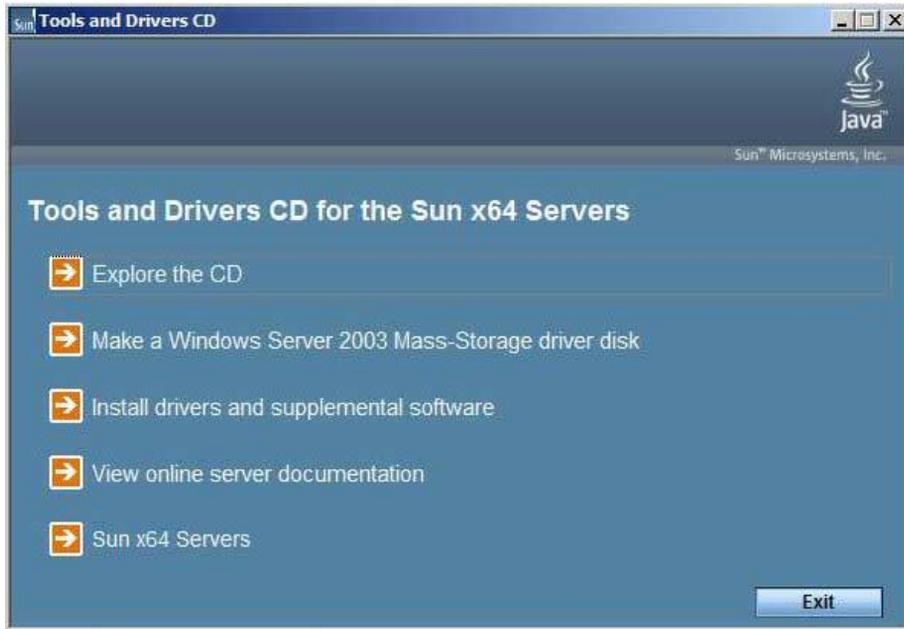
FIGURE 4-1 Tools and Drivers CD/DVD autorun menu

The autorun menu in the Tools and Drivers DVD displays "Make a Windows Server 2003 Mass-Storage driver disk" as an option. This option is not available on the Sun Blade X6275 Server Module. Selecting this option will result in an error message. This error message can be ignored.
