Sun Blade X6275 Server Module

Product Notes

Part No.: Part No.: E20849-04,
May 2013

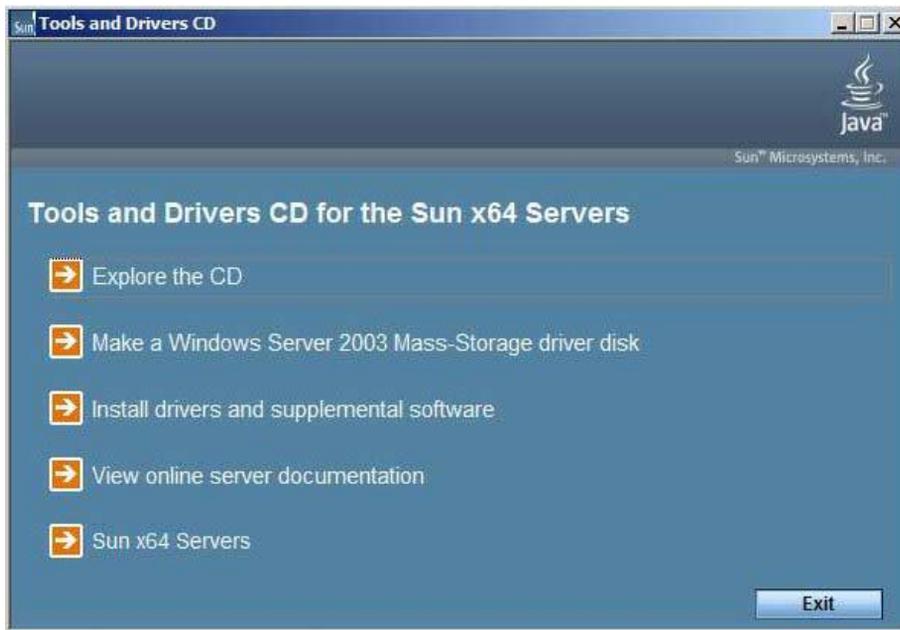
FIGURE 4-1 Tools and Drivers CD/DVD autorun menu

The autorun menu in the Tools and Drivers DVD displays "Make a Windows Server 2003 Mass-Storage driver disk" as an option. This option is not available on the Sun Blade X6275 Server Module. Selecting this option will result in an error message. This error message can be ignored.
