SPARC T3-1 Server

Product Notes

Part No.: E20747-10
August 2012

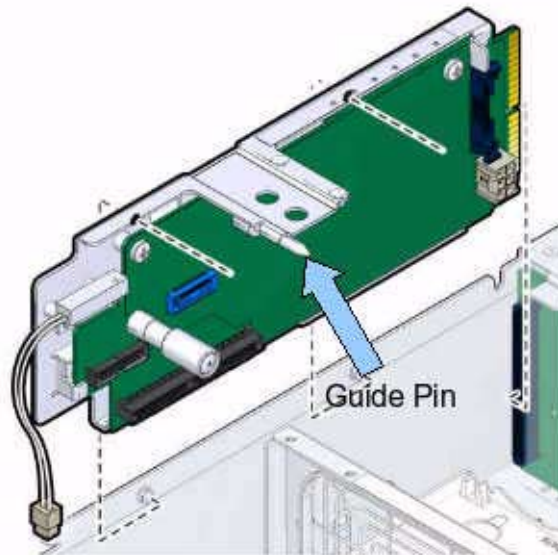
Caution Needed When Handling the Connector Board

Use caution when handling the connector board to avoid pressing your hand against the pointed end of the guide pin that's located below the mounting bracket. The guide pin is indicated by an arrow in the following figure.
