Sun Blade X6270 M2 Server Module

Product Notes, Software Release 1.4

Part No.: E22381-07
February 2013

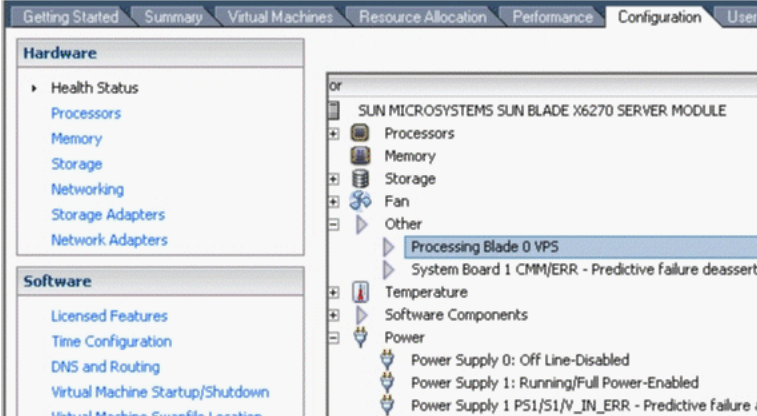
CR	Description
6779112	<p data-bbox="415 239 1233 291">Misleading Status for Power Supplies Is Reported by VMware Health Status Screen</p> <p data-bbox="415 314 479 335">Issue:</p> <p data-bbox="415 348 1233 427">The VMware Virtual Infrastructure client Health Status screen under the Power component reports the server power supplies in an Off-Line Disabled state and 0 watts, even though the power supplies are on-line and enabled.</p> <p data-bbox="415 447 615 468">Affected Software:</p> <ul data-bbox="415 479 711 499" style="list-style-type: none"> • VMware ESX 4.0 Update 1 <p data-bbox="415 522 558 543">Workaround:</p> <p data-bbox="415 557 1205 635">To view the correct power status while in the VMware Virtual Infrastructure client Health Status screen, click on the Other component from the list of available options and view the blade <i>n</i> VPS (where <i>n</i> is the blade number).</p>
