Sun Fire™ X2200 M2 Server Product Notes

Part No. 819-6601-22
July 2009, Revision A

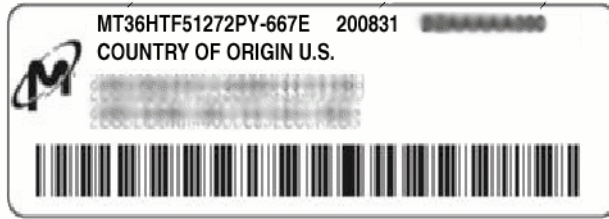
- **Use the sample label and the information presented here to visually inspect the 4 GB DIMMs in your server:**

The affected DIMMs can be identified by the Micron logo and the first two number strings on the label.

- Affected DIMMs have a Micron product logo, as shown in the above illustration.
- The first string is an alpha-numeric string. This is the vendor's part number. On affected DIMMs the part number is MT36HTF51272PY-667E.
- The second number string is the manufacturing date code. On affected DIMMs the string is a value *lower* than 200832, indicating that the DIMM was manufactured before the 32nd week of 2008.

Boot Failures and System Crashes With 4 GB DIMMs and Quad-Core CPUs

To determine if you have affected DIMMs installed in your server:
