Sun Fire™ X4500 Server Release Notes for Software Releases 1.4, 1.5, 1.6, and 1.7

Part No. 820-3840-14
September 2009, Revision A

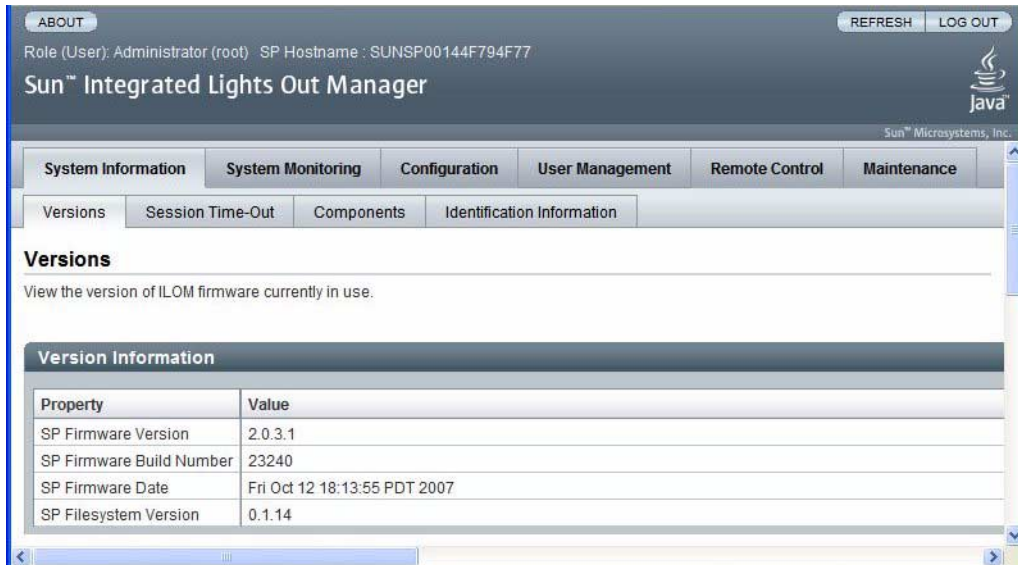
FIGURE 1-1 System Information Version

The first web page that is presented is the System Information -> Versions page, which includes the Build Number.

The screenshot shows the Sun Integrated Lights Out Manager (ILOM) web interface. The page title is "Sun™ Integrated Lights Out Manager" and the user role is "Administrator (root)". The page is divided into several tabs: "System Information", "System Monitoring", "Configuration", "User Management", "Remote Control", and "Maintenance". Under "System Information", there are sub-tabs: "Versions", "Session Time-Out", "Components", and "Identification Information". The "Versions" sub-tab is selected, and the page displays the following version information:

Property	Value
SP Firmware Version	2.0.3.1
SP Firmware Build Number	23240
SP Firmware Date	Fri Oct 12 18:13:55 PDT 2007
SP Filesystem Version	0.1.14

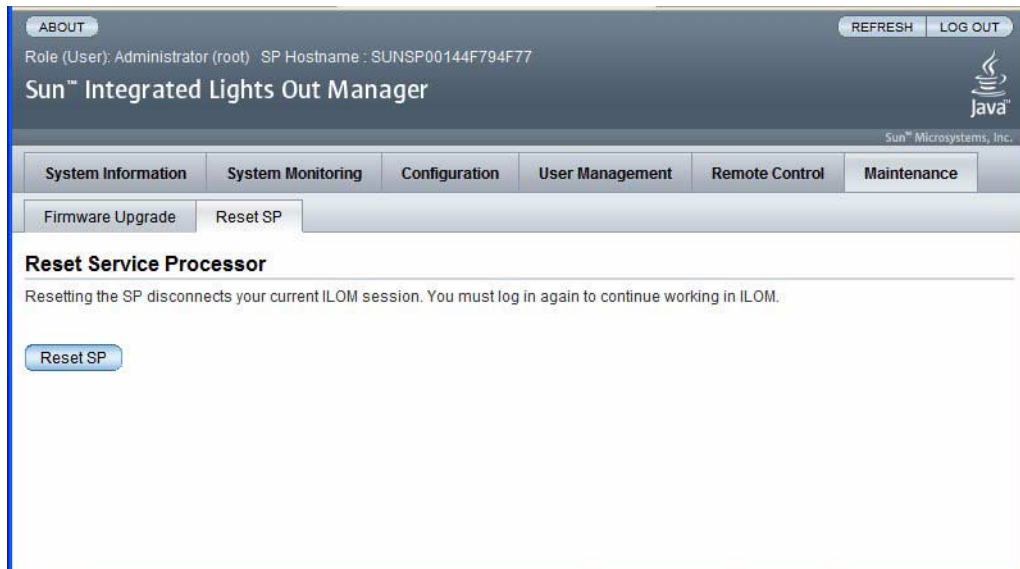
FIGURE 1-2 Reset Service Processor

- From the ILOM SP graphical Web interface, navigate to the Maintenance tab and the Reset SP tab, and then click the Reset SP button.

- From the ILOM CLI, use the following command:
`reset /SP`
 - Using IPMITool, use the following command:
`ipmitool -U root -P password -H SP-IP bmc reset cold`
- where *SP-IP* is the IP address of the service processor.
