# Sun Storage 6180 Array Release Notes

Release 6.5

Part No. 821-0265-11  
March 2010, Revision A

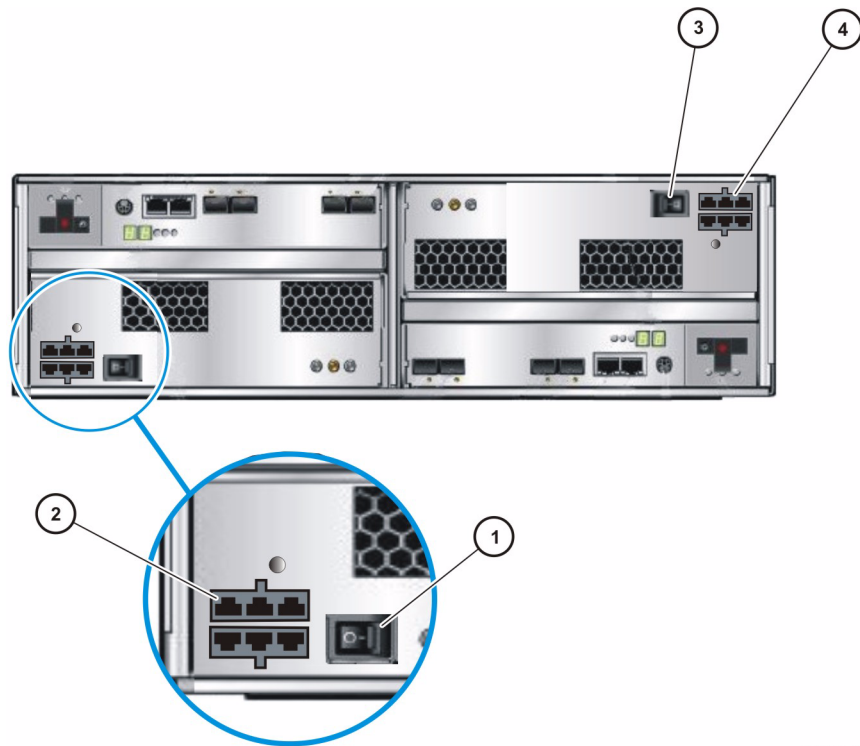
**FIGURE 1** Sun Storage 6180 Array DC Power Option (Rear)

Correction—[FIGURE 1](#) shows the location of the DC power connector and DC power switch at the back of each controller.

Power Supply B		Power Supply A	
1	DC power switch	3	DC power switch
2	DC power connectors	4	DC power connectors
